Preventing Dark Streaks in Trivalent Chromium

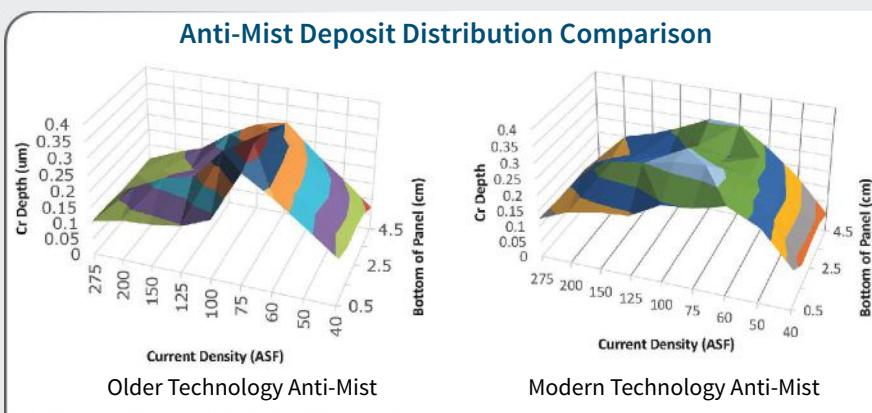
Insufficient Anti-Mist Additive: Anti-mist additives are designed to lower the surface tension of the working solution and improve deposit distribution. Modern (newer technology) anti-mist additives also provide additional resistance to metallic contamination. The graphs below show the comparison of deposit distribution through the use of older technology anti-mist versus modern technology anti-mist additive. The anti-mist additives are generally consumed in very small amounts and can be analyzed using a tensiometer or any other means to check surface tension in the solution. Please refer to your supplier's recommendations for specific anti-mist ranges as these components can vary from supplier to supplier. When the anti-mist additive is not sufficiently maintained or relies on older technology, the deposit distribution can be affected, leading to a darker deposit or dark streaks.
